Report No. DODIG-2012-132 September 14, 2012

United States  
Department of Defense

## Project Planning Resulted in Outstanding Building Deficiencies and Decreased Functionality of the Main Fire Station at Naval Station Great Lakes

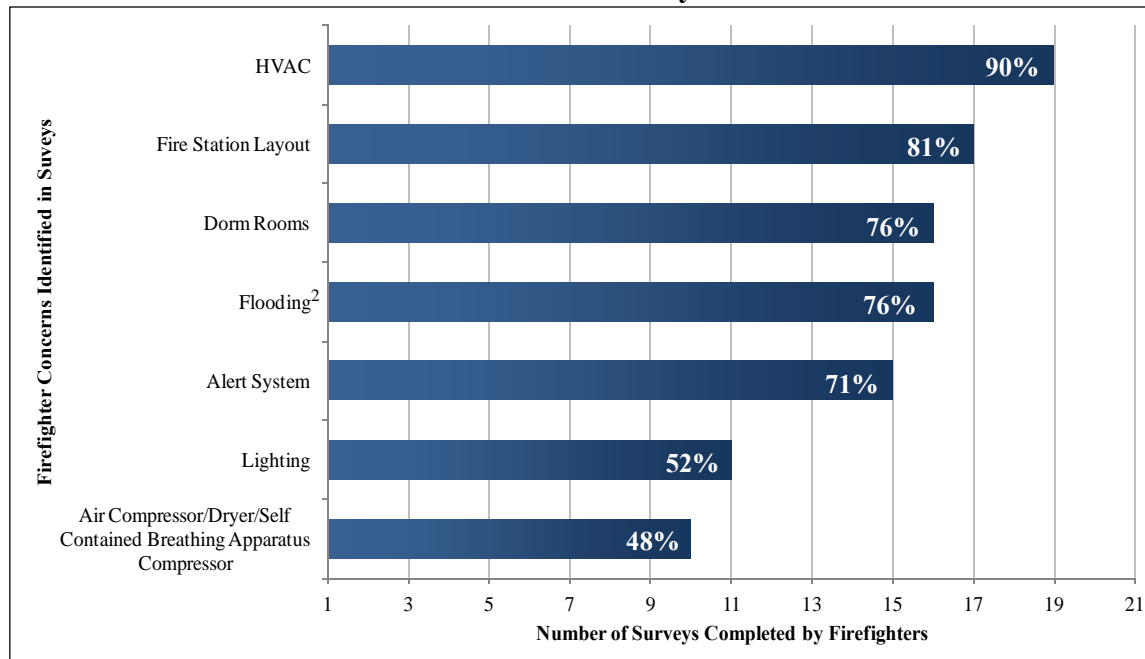
**Figure 5. Top Concerns That 21 Firefighters Identified in the DoD OIG Survey<sup>1</sup>**

<sup>1</sup>The percentages in this figure apply to the 21 firefighters who responded to our survey. This figure reflects the number of surveys that identified each concern.

<sup>2</sup> Firefighters identified flooding as a top concern on the surveys. However, NAVFAC Midwest officials explained that this problem was not specific to the fire station; rather it was an installation infrastructure problem. See report page 22 for additional discussion and planned corrective actions.
